TECHNICAL REPORT N-70-10

**SURVEY OF GULF COAST  
STRUCTURAL DAMAGE RESULTING FROM  
HURRICANE CAMILLE, AUGUST 1969**

**M. E. Criswell, R. S. Cummins**

**April 1970**

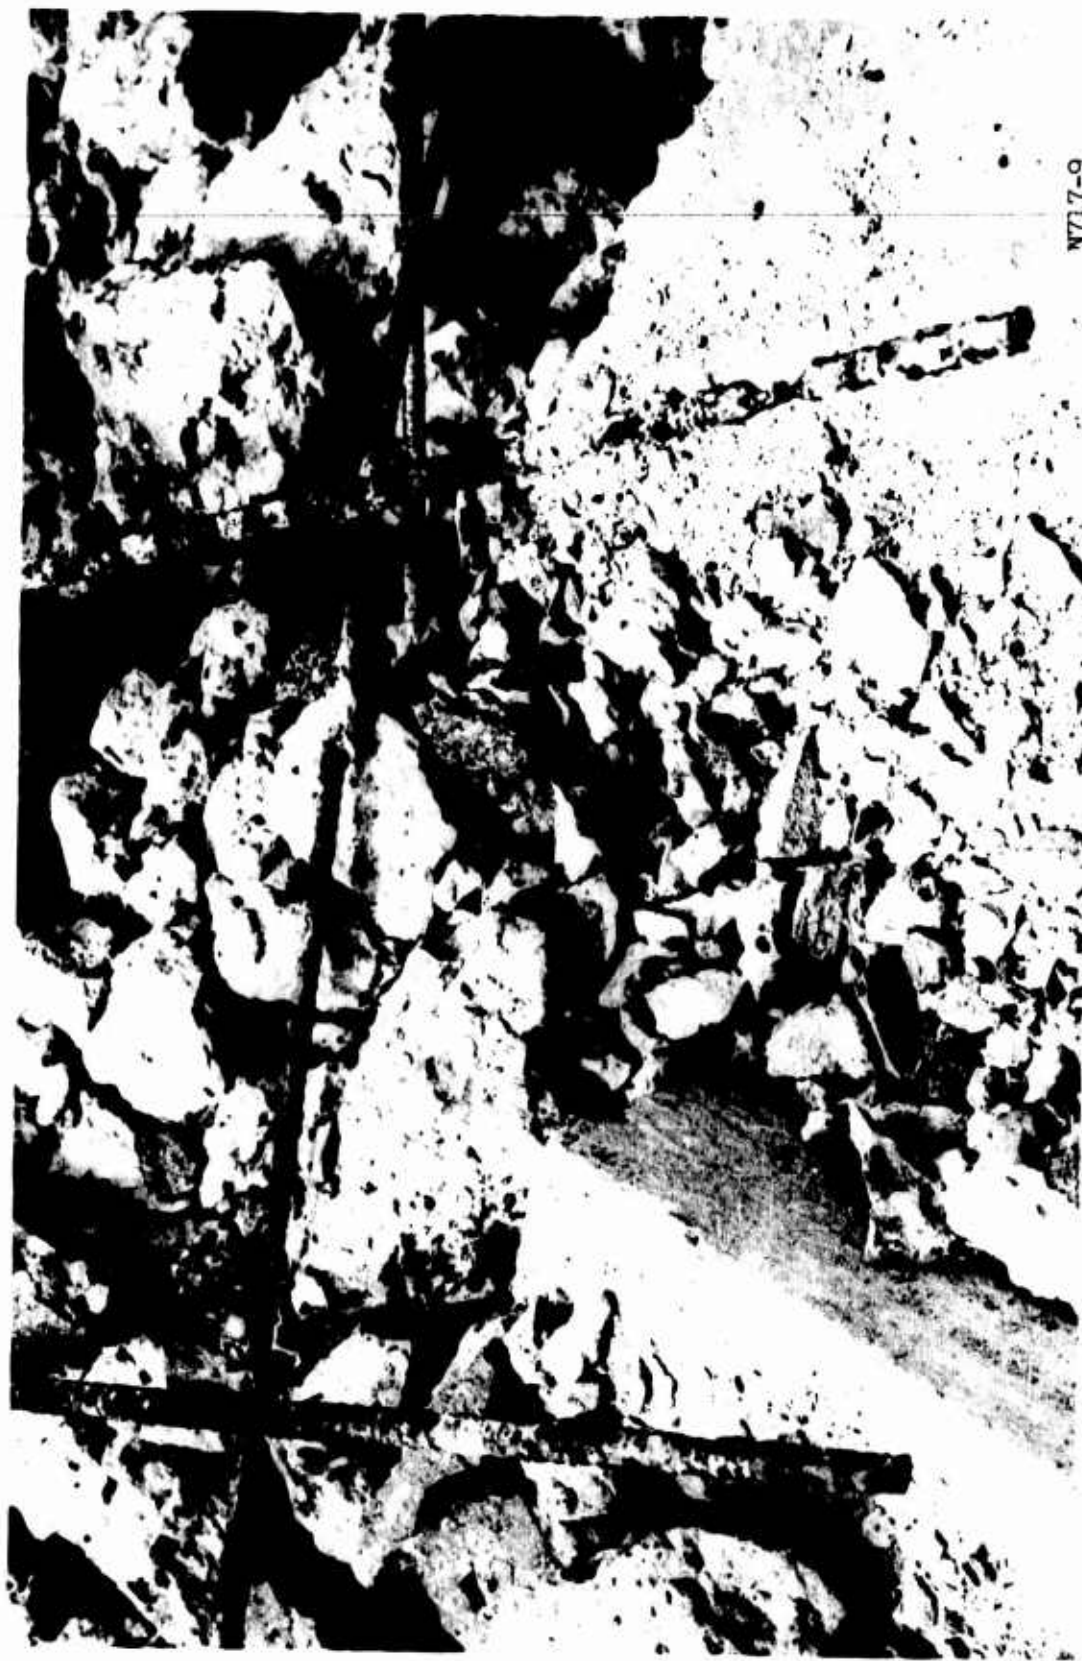
W717-9

Figure 3.26 Reinforcement corrosion in a slab, Marine Life.
